# Analysis of Leakage Failure in Coiled Tubing

Runqiu Gao, Dong Jian and Yueming Liu

DSHINDA(TANGSHAN) CREATIVE OIL & GAS EQUIPMENT CO.,LTD, Tangshan 063000, China

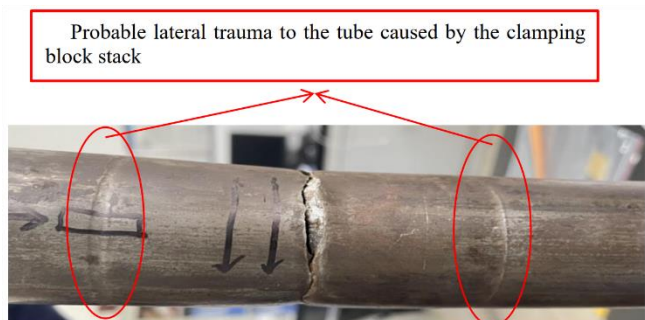
Figure 1. Causing lateral damage exist at both ends of the fractured tubing

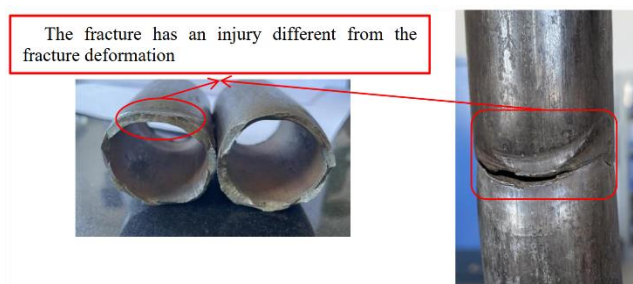
Figure 2. Overall morphology of fracture

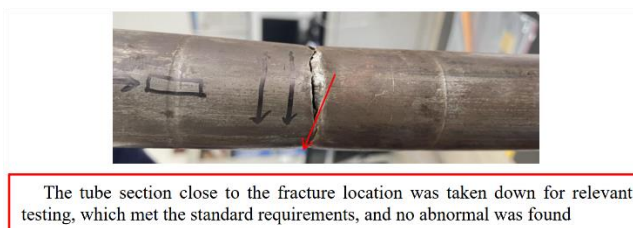
Figure 3. The location near the fracture

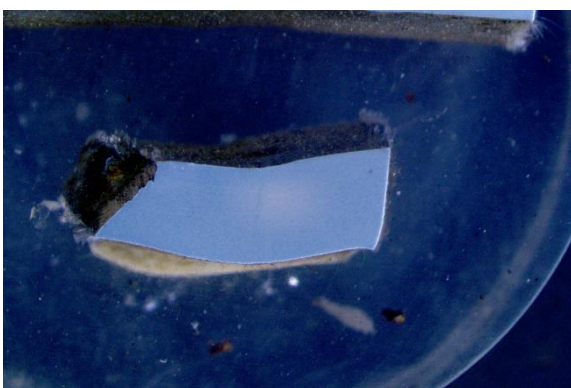
**Figure 10. Macroscopic surface 6.8X**

Sample the area of the A1 tube containing the injury, YJ-2000 metallographic microscope and image analysis system were used to conduct grain size analysis according to ASTM E112-2013 standard. The results are shown in Table 5. The results show that the grain size of the sample meets the technical requirements, However, the wall thickness at the damaged site became thinner and deformed.

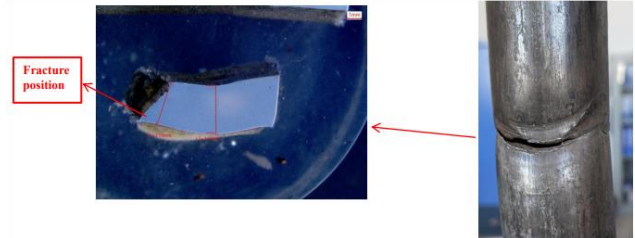
Fracture has damage different from fracture deformation, which is not caused by tube fracture, but by external machinery. Taking out this part for testing, it is found that the hardness of this part is higher than that of the matrix, which reduces the plastic toughness of the tube.

**Figure 11. The macroscopic picture shows obvious deformation and the wall thickness at the breaking point is reduced 6.8X**

There is mechanical trauma in the fracture and suspected improper operation on both sides of the fracture position, which causes the tube body damage by the stacking of the clamping blocks, that will cause the deformation of the coiled tubing. The thinning of the wall thickness and the increase of hardness will reduce the strength of the tubing, which is the main reason for the fracture of the coiled tubing [4].

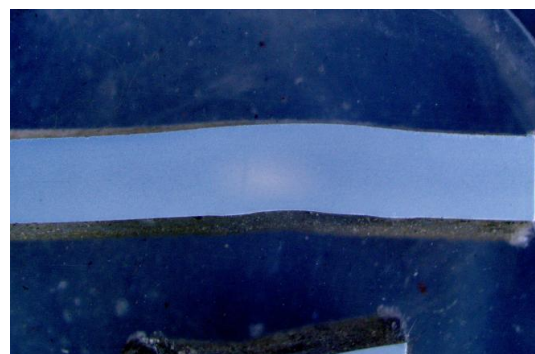
**Figure 13. Macroscopic surface 6.8X**

Sample A2 was sampled at the location of the tube side damage that may have been caused by the clamping block, YJ-2000 metallographic microscope and image analysis system were used to conduct grain size analysis according to ASTM E112-2013 standard. The results are shown in Table 6. The results show that the grain size of the sample meets the technical requirements, However, the wall thickness at the damaged site became deformed [3].

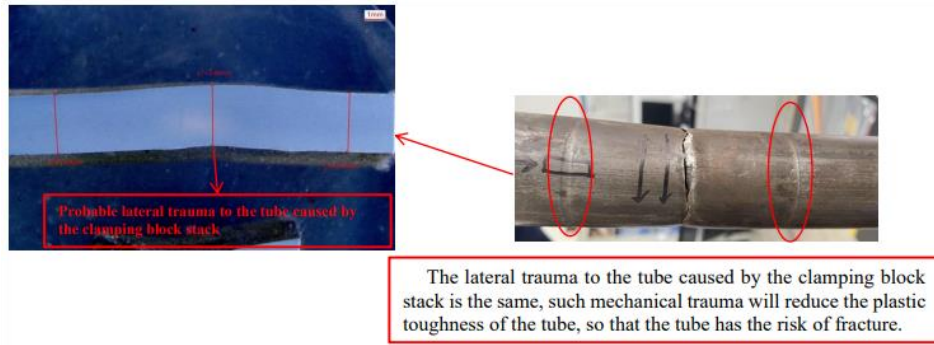
Figure 14. The macroscopic picture shows the wall thickness at the damaged site became deformed 6.8X
