# Analysis of Leakage Failure in Coiled Tubing

Runqiu Gao, Dong Jian and Yueming Liu

DSHINDA(TANGSHAN) CREATIVE OIL & GAS EQUIPMENT CO.,LTD, Tangshan 063000, China

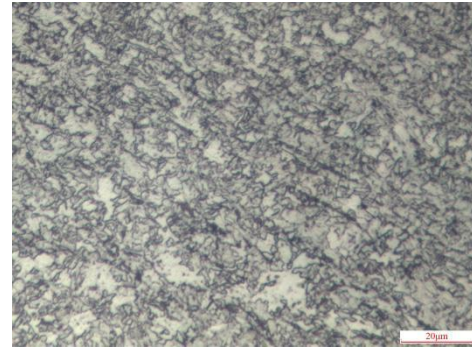
**Figure 6.** Base material 500X

Cut off a section of tube ring near the A2 fracture, for A2, YJ-2000 metallographic microscope and image analysis system were used to conduct grain size analysis according to ASTM E112-2013 standard. The results are shown in Table 3. The results show that the grain size of the sample meets the technical requirements, metallographic structure was not abnormal.

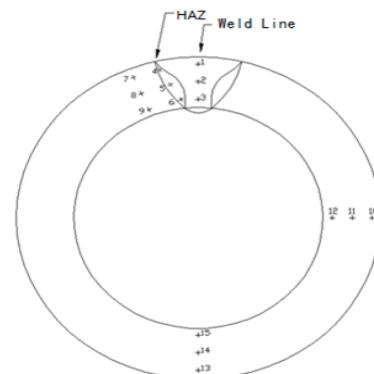
**Figure 8.** Through-wall Hardness Test Impression Location

Cut off a section of tube ring near the A2 fracture, for A2, 200HVS-5 digital display small-load Vickers hardness tester was used to perform the hardness test according to ASTM E384-22 standards, and the hardness conversion was performed according to ASTM E140-2012b (2019) e1. The hardness test position of the original tube is shown in Figure 8, and the data are shown in Table 4. The results show that, the hardness data meet the technical requirements and the hardness is uniform.

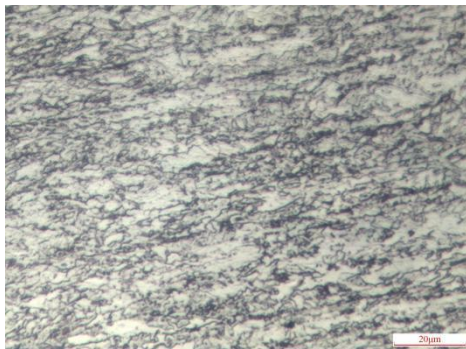
**Figure 9. Base material 500X**

Sample the area of the A1 tube containing the injury, YJ-2000 metallographic microscope and image analysis system were used to conduct grain size analysis according to ASTM E112-2013 standard. The results are shown in Table 5. The results show that the grain size of the sample meets the technical requirements, However, the wall thickness at the damaged site became thinner and deformed.

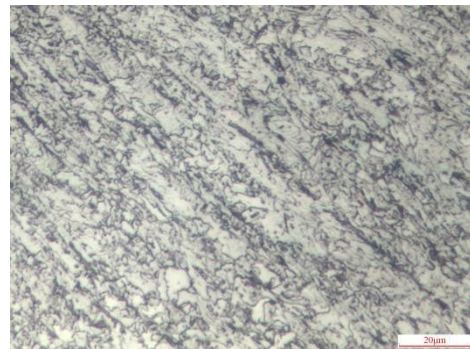
**Figure 12. Base material 500X**

Sample A2 was sampled at the location of the tube side damage that may have been caused by the clamping block, YJ-2000 metallographic microscope and image analysis system were used to conduct grain size analysis according to ASTM E112-2013 standard. The results are shown in Table 6. The results show that the grain size of the sample meets the technical requirements, However, the wall thickness at the damaged site became deformed [3].
